Delta-Therm Ice Melt Cables Preserve and Protect Chicago Landmark

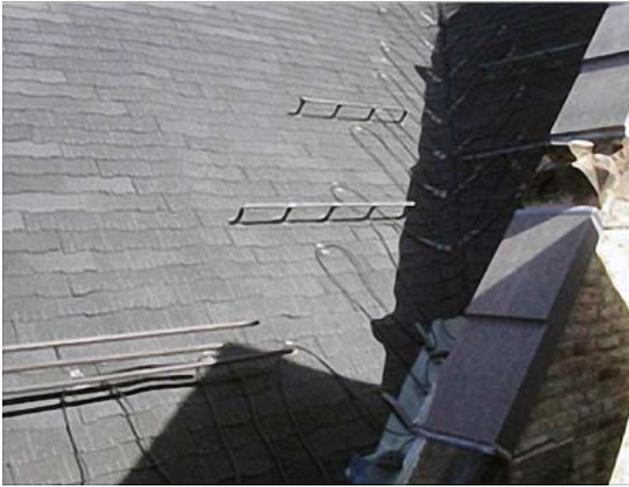
Delta-Therm deicing cable is installed behind the brick façade to create a heated drain path for snow melt water to follow.

Renovations at the church took place over a period of 10 years. To address the frozen waterfall, in 2001, 1,200 feet of Delta-Therm's mineral insulated roof deicing cable assemblies were installed in a zig zag pattern, attached at the lower two feet of the lowest part of the gabled roof. Melt water was sent down a drain. "The roof deicing system was designed to be removable because they were going to replace the roof," said Ada Cryer of Delta-Therm. When
